Subject: Hawaii Electric Light Company, Inc.  
March 2013 Kaumana-Pohoiki 6500 Line Events

## **March 2013 Kaumana-Pohoiki 6500 Line Events**

Prepared by HELCO Distribution Department

4/30/2013

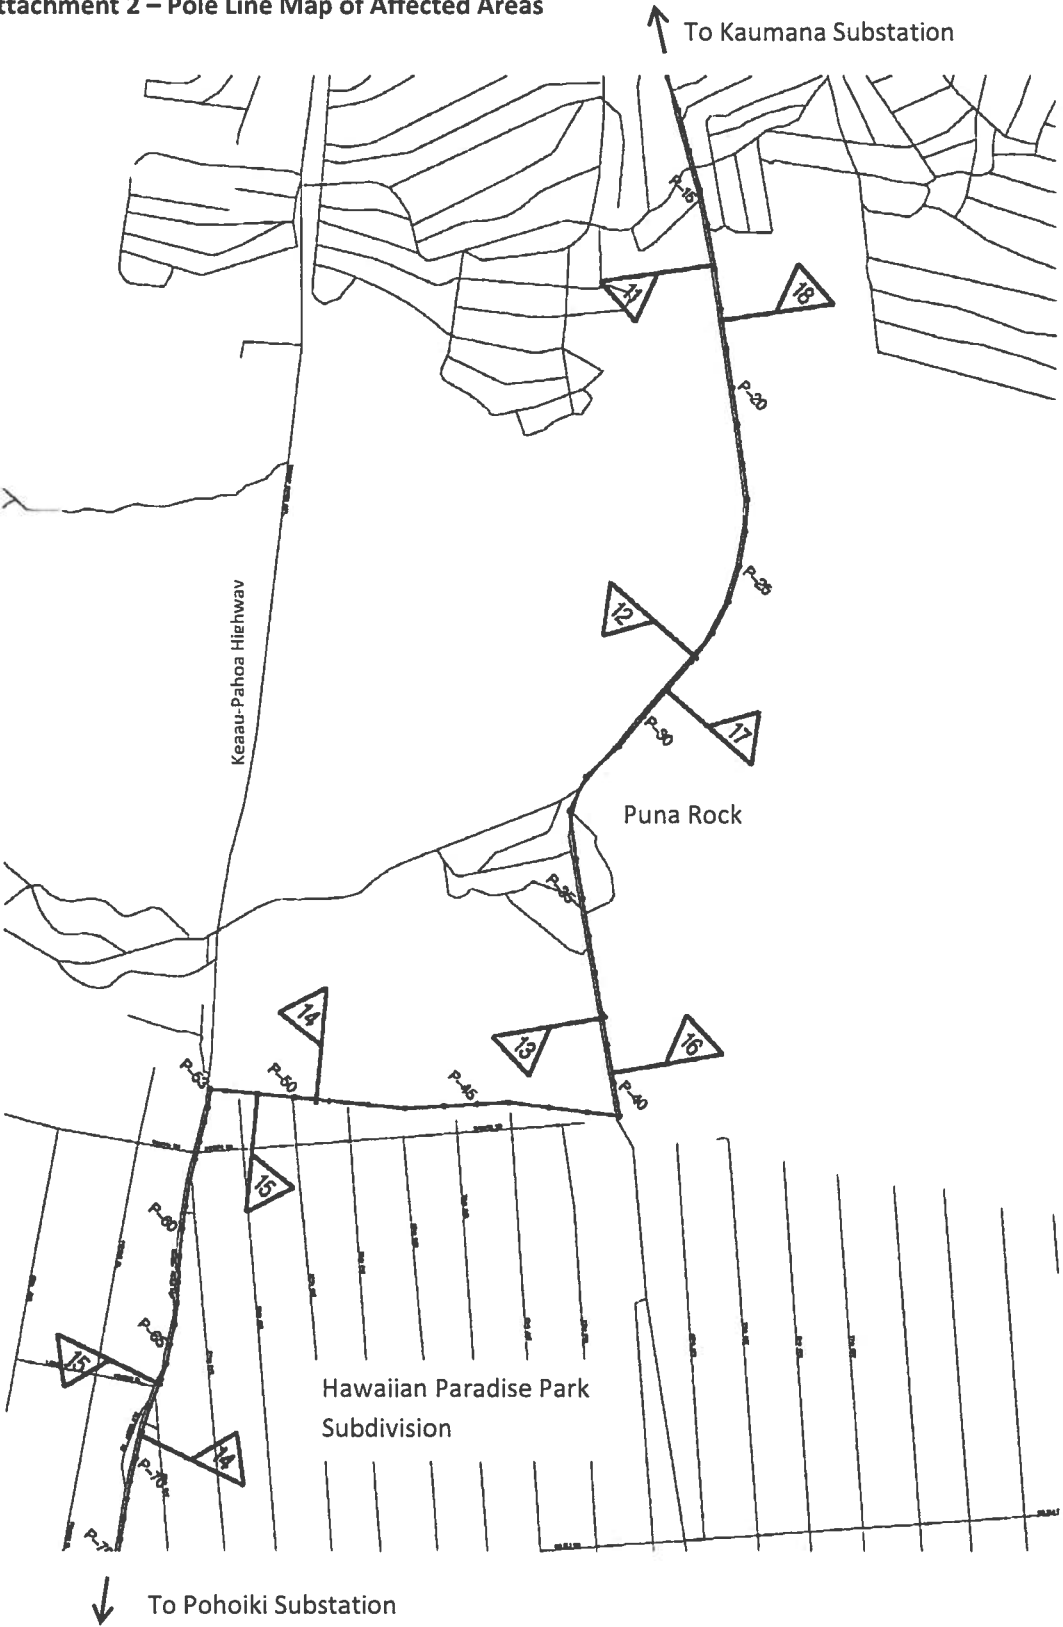
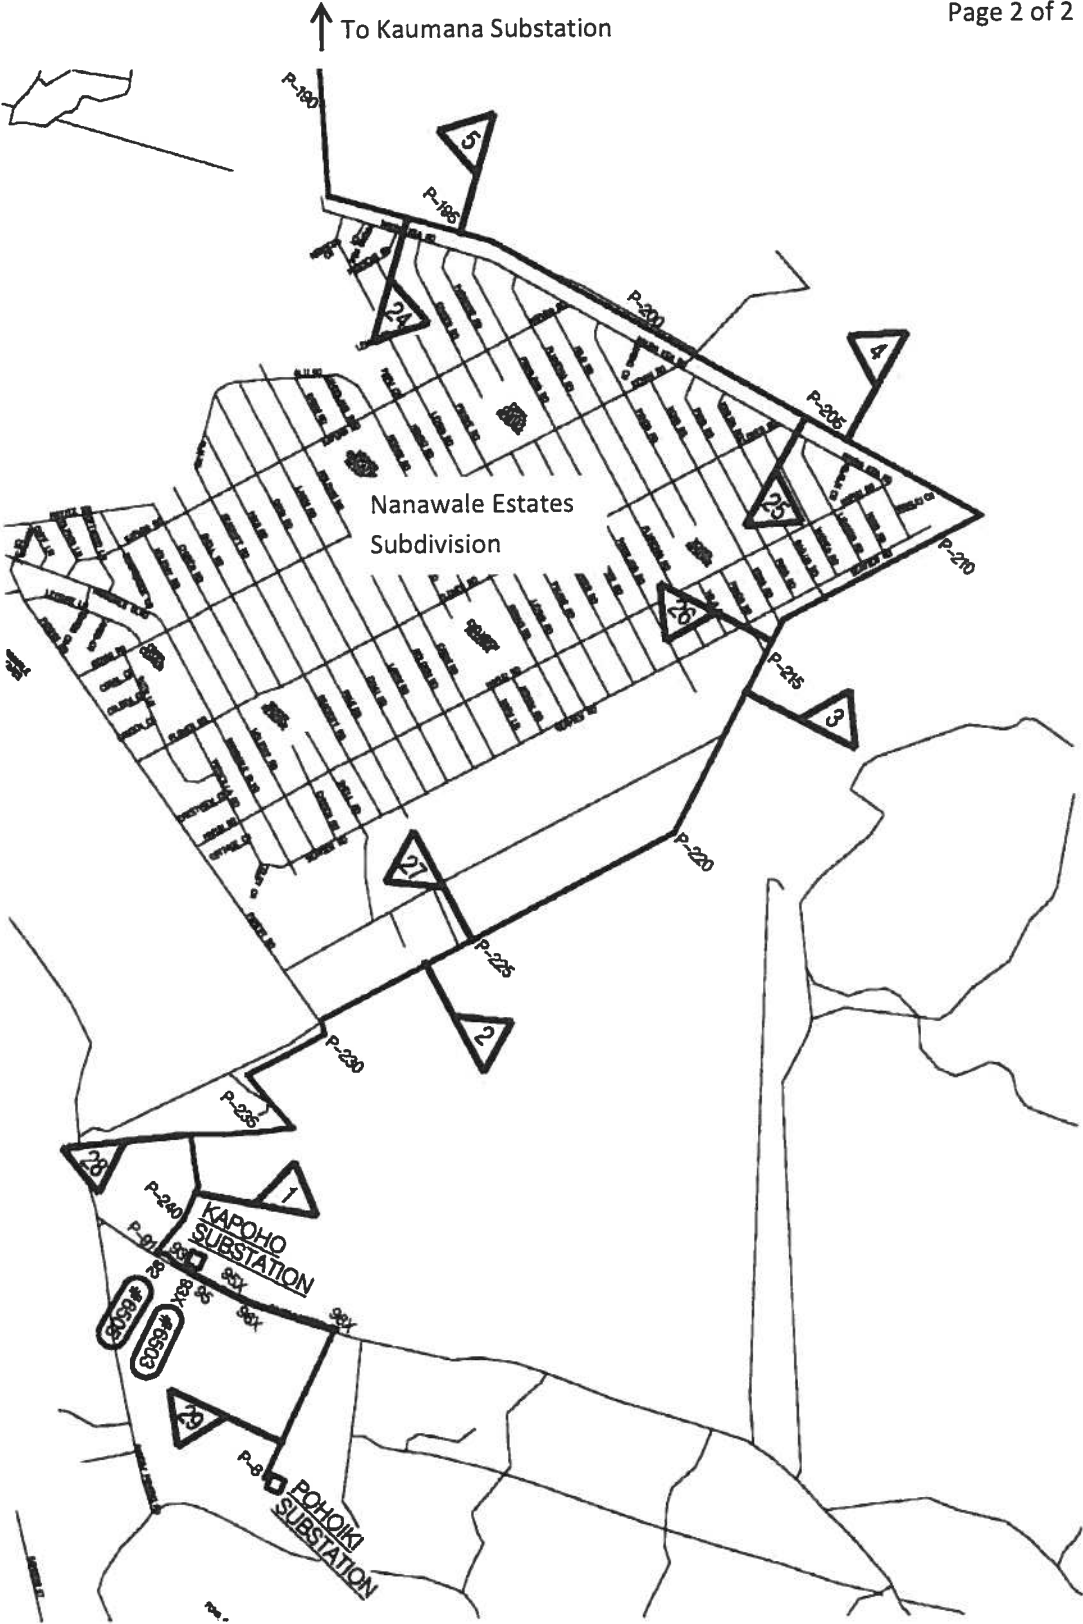
Attachment 2 – Pole Line Map of Affected Areas

On Monday, 3/11/13, the two T/I's visually inspected the 6500 line in spots close to the fault locations provided by the relays and found the line to be clear. Both of these spots are not easily accessible since they are not located near roads and also have trees along the route. One T/I visually inspected the area from pole P3, near the Puna substation, to pole P31, near Puna Rock on old Railroad Ave (event 2 fault location). The other T/I visually inspected from poles P214 to P222 behind Nanawale Estates (event 1 fault location). This required walking in areas because there was no driving access. The T/I also visually inspected the area when it was dark to see if there was any tracking (i.e., visible arcing) on the insulators. No problems were found. (See Attachment 2 – Pole Line Map of Affected Areas.)

The search for the problem on the 6500 line intensified that evening. The fault distance for event 4 placed the problem near Nanawale Estates, similar to event 1. The T/I traced the line Wednesday night from poles P200 to P192, and from poles P200 to P207. The line appeared to be clear and no problem was found. (See Attachment 2 – Pole Line Map of Affected Areas.)

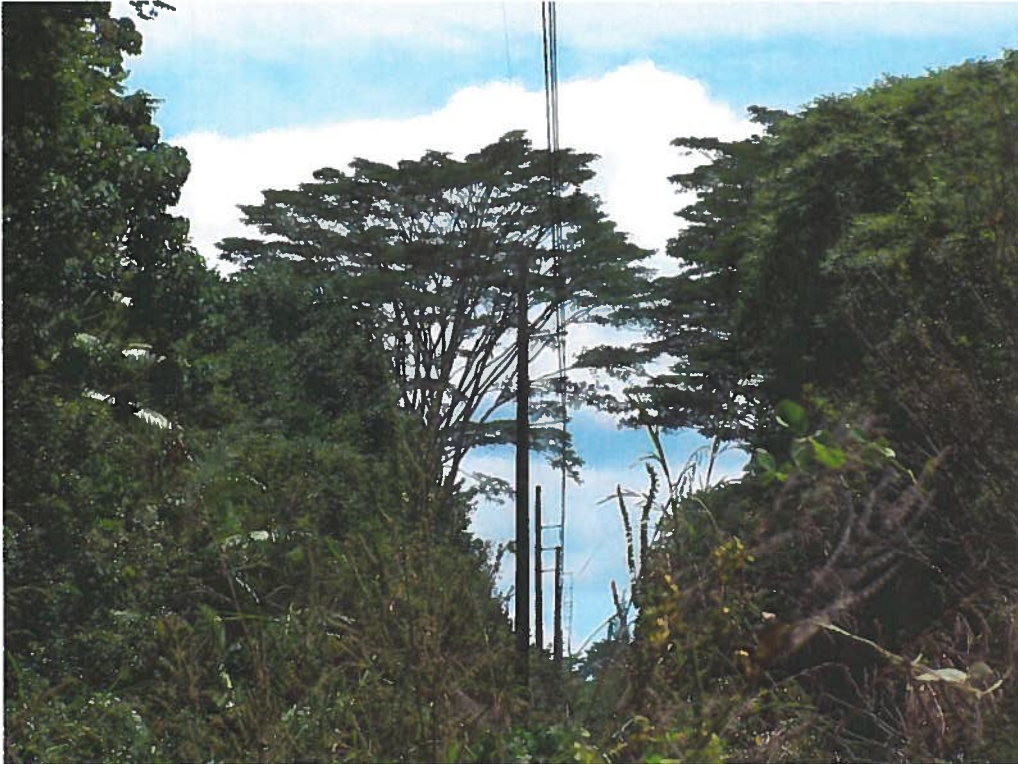
P36-P37 near Puna Rock

were found. Some trees were noted below the line between poles P37 and P38, and a canopy of trees over the lines between poles P35 and P37. Behind Nanawale Estates, from poles P195 to P220, trees were trimmed before but now there were some overhanging branches.

On Monday, 3/18/13, line crews with buckets inspected pole-by-pole from pole P3 to pole P41. SWO #6500-118 opened the line between SW 6508 and SW 6509. The crews found some burnt branches (not albizia) on the ground between poles P37 and P38, which could possibly have been the cause of a fault. Other than that, the insulators looked good.

On Saturday, 3/16/13, tree trimmers worked in the area of the 6500 line between pole P3 near the Puna substation and pole P41 near Shower Drive, HPP (event 2 and 3 fault locations).

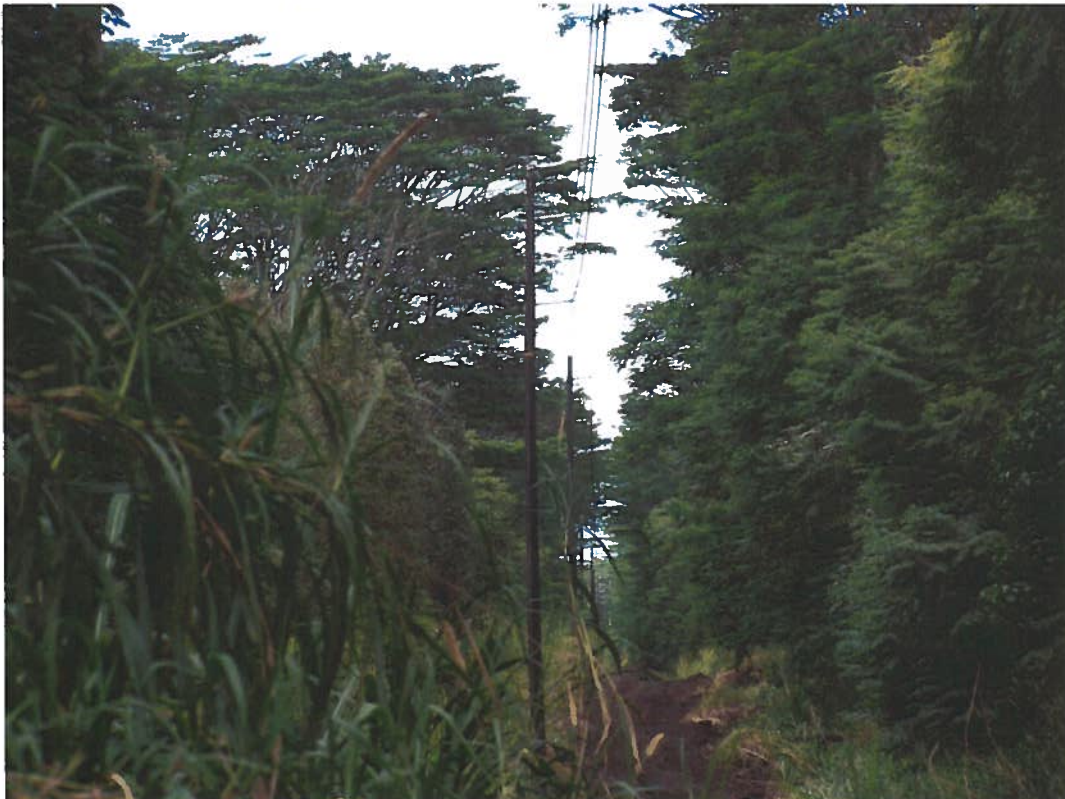
P220-P229 near Nanawale Estates

At 09:34:08, CBs 6501/7011 at the Pohoiki substation and CB 6502 at the Kaumana substation opened again and reclosed automatically at 09:34:12 due to a HELCO contractor dropping a tree on the 69 kV transmission line. The contractor was trimming trees between pole P222 and pole P223 near Nanawale Estates. Power was interrupted for approximately 4 seconds to the same 9,520 customers. The contractor's safety rules and procedures are being reviewed.

Comprehensive tree trimming continued during the week of 3/25-3/29 from poles P205 to P209 and from poles P214 to P230. (Attachment 3 contains pictures taken on 3/26/13 of the 6500 line.) To-date, over 2,700 trees have been either cut down or trimmed.
